Manhole Inspection Summary

Manhole # S27E__058MH

Insp Date: **4/2/08 1:49 PM**

Location Address: **949 LEXINGTON ST**

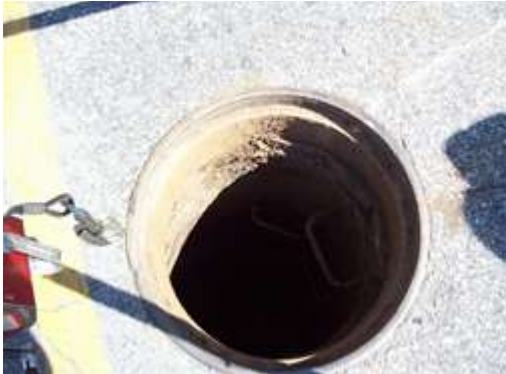
Defect 1

Frame Offset: **2** (in.) Condition: ☒ Sound ☐ Cracked ☐ Leaks

FRAME OFFSET

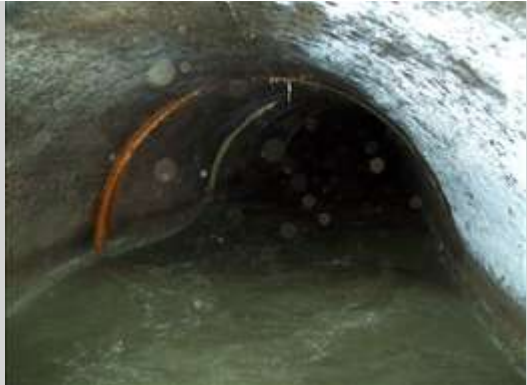
12 O'Clock Outflow

60 in. Circular Gravity Sewer
Pipe Out @ 12 O'Clock

Pipe Height: (in.) Direct
Pipe Material: **Concrete** ☐ Pipe Lined
Invert Depth: **26.33** (ft.) Flow Characteristics: **Fast**
Deposits: ☒ None ☐ Mud ☐ Sludge ☐ Debris ☐ Grease
Silt Depth: (in.) Deposits Extent:
Infiltration: **None** Pipe Seal Cond: **Sound**

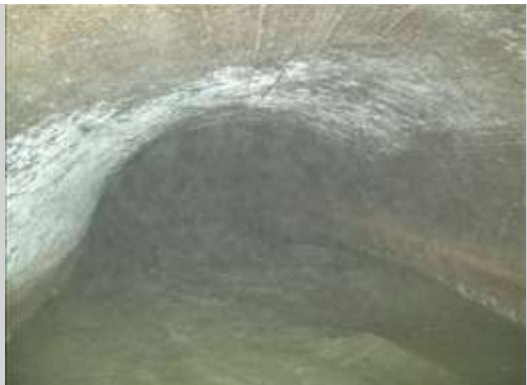
6 O'Clock Inflow

60 in. Circular Gravity Sewer
Pipe In @ 6 O'Clock

Pipe Height: (in.) Direct
Pipe Material: **Concrete** ☐ Pipe Lined
Invert Depth: **26.31** (ft.) Flow Characteristics: **Fast**
Deposits: ☒ None ☐ Mud ☐ Sludge ☐ Debris ☐ Grease
Silt Depth: (in.) Deposits Extent:
Infiltration: **None** Pipe Seal Cond: **Sound**
